# Intelligent Inspections

## Demo\_Suite

2026-04-19 21:34

On April 19, 2026, a multi-sensor inspection was performed on Industrial Hose phase3a\_hose using 1 sensors (Sensor 1). Overall severity: **7/10 — ACTION**. Action-level condition. Corrective action recommended to prevent progression. 1 findings require action.

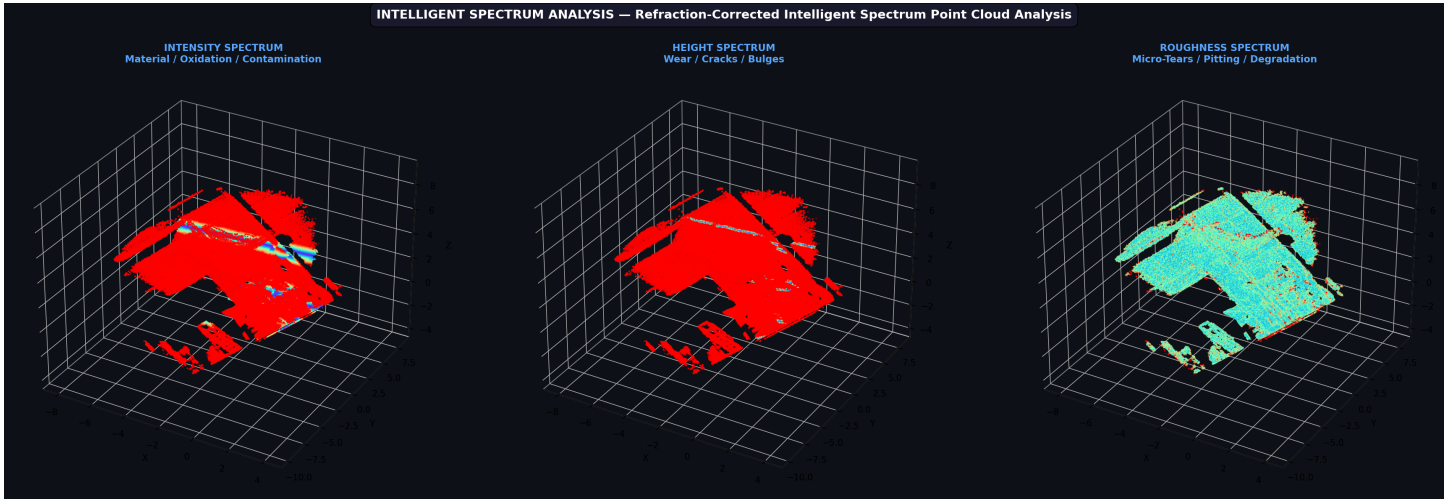
**Intelligent Spectrum Analysis:** Full-spectrum point cloud visualization. 7,910 roughness anomalies and 6,442 height anomalies detected. Intensity maps material/oxidation changes. Height maps wear/cracks/bulges. Roughness maps micro-tears/pitting/early degradation.

Left: Intensity Spectrum (material) | Center: Height Spectrum (wear) | Right: Roughness Spectrum (degradation)
