Intelligent Inspections

Demo

2026-04-19 19:49

On April 19, 2026, a multi-sensor inspection was performed on Belt Conveyor belt_conveyor using 4 sensors (Sensor 1, Sensor 2, Sensor 3, Sensor 5). Overall severity: **9/10 — CRITICAL**. Critical condition identified. Immediate attention recommended. 2 findings require action.

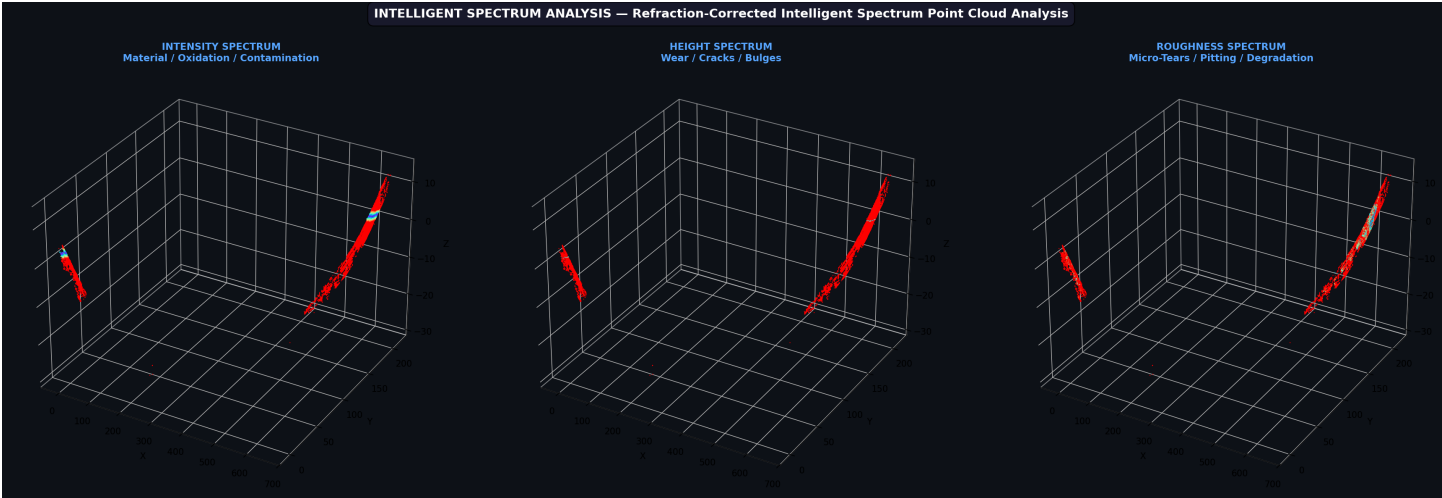
Intelligent Spectrum Analysis: Full-spectrum point cloud visualization. 15,000 roughness anomalies and 18,679 height anomalies detected. Intensity maps material/oxidation changes. Height maps wear/cracks/bulges. Roughness maps micro-tears/pitting/early degradation.

Left: Intensity Spectrum (material) | Center: Height Spectrum (wear) | Right: Roughness Spectrum (degradation)

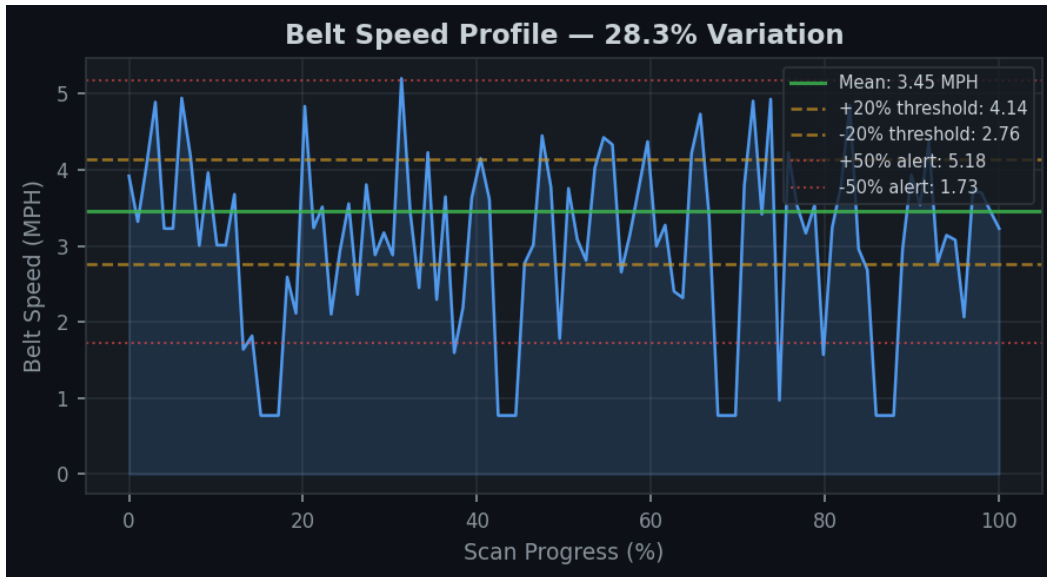
Belt speed with threshold overlays (yellow=watch, red=alert)

Interpretation: Speed variation of 28.3% exceeds the 10% acceptable threshold. Belt slip, tension loss, or drive control issues are indicated. Cross-reference with vibration data to determine if mechanical misalignment is contributing to speed instability.

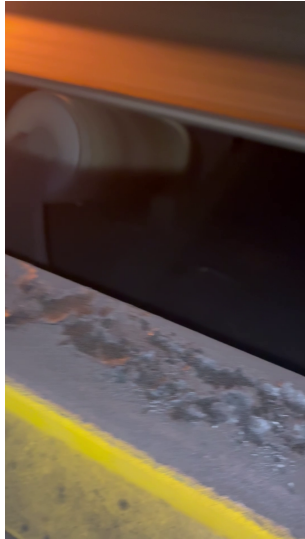
3rd_from_head_20260419_194539_frame.png

In plain terms: The visual inspection found signs of surface degradation. 9 potential belt tear(s) or surface damage was detected. See the images and color analysis below for details.

Defect Type	Finding	Severity	Recommendation
Tears / Cuts	9	9/10	CRITICAL — tear spans >30% of belt width. Immediate repair required.
Gouges	1	6/10	Monitor depth and progression
Delamination	3 area(s)	8/10	Schedule belt cover repair
Rip Detected	YES	9/10	IMMEDIATE — risk of belt failure
Cover Condition	35%	8/10	Overall surface integrity
