Intelligent Inspections

Test_Scan

2026-04-19 22:19

On April 19, 2026, a multi-sensor inspection was performed on Test Belt Conveyor test_belt_conveyor using 1 sensors (Sensor 1). Overall severity: **7/10 — ACTION**. Action-level condition. Corrective action recommended to prevent progression. 1 findings require action.

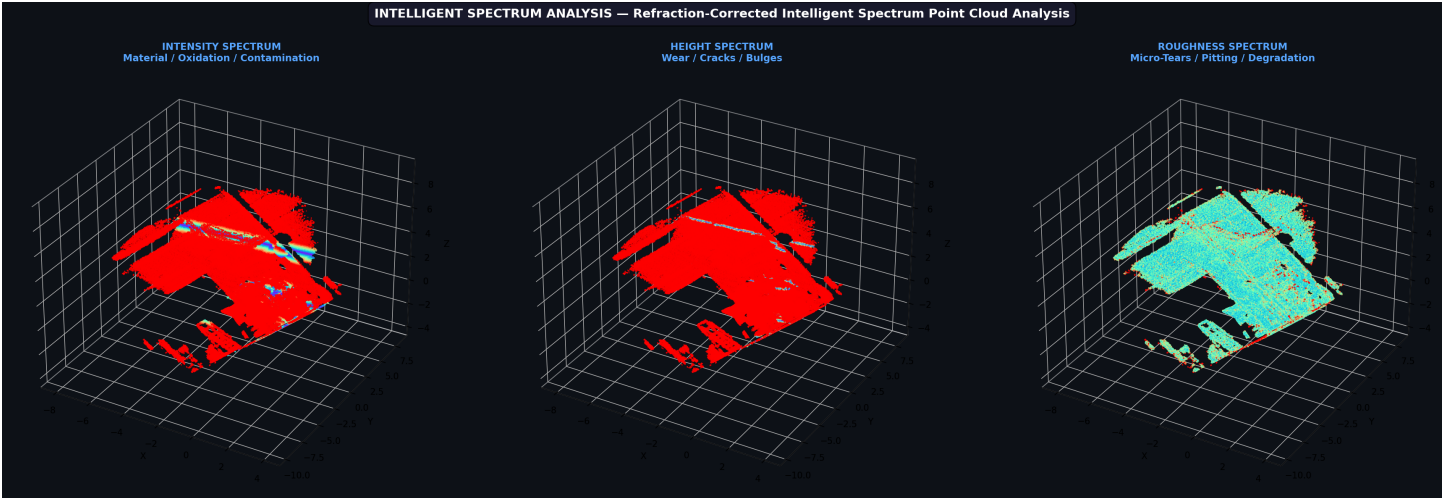
INTELLIGENT SPECTRUM ANALYSIS

Intelligent Spectrum Analysis: Full-spectrum point cloud visualization. 8,005 roughness anomalies and 6,644 height anomalies detected. Intensity maps material/oxidation changes. Height maps wear/cracks/bulges. Roughness maps micro-tears/pitting/early degradation.

Left: Intensity Spectrum (material) | Center: Height Spectrum (wear) | Right: Roughness Spectrum (degradation)
