Intelligent Inspections

Demo

2026-04-19 19:49

On April 19, 2026, a multi-sensor inspection was performed on Belt Conveyor belt_conveyor using 4 sensors (Sensor 1, Sensor 2, Sensor 3, Sensor 5). Overall severity: **9/10 — CRITICAL**. Critical condition identified. Immediate attention recommended. 2 findings require action.

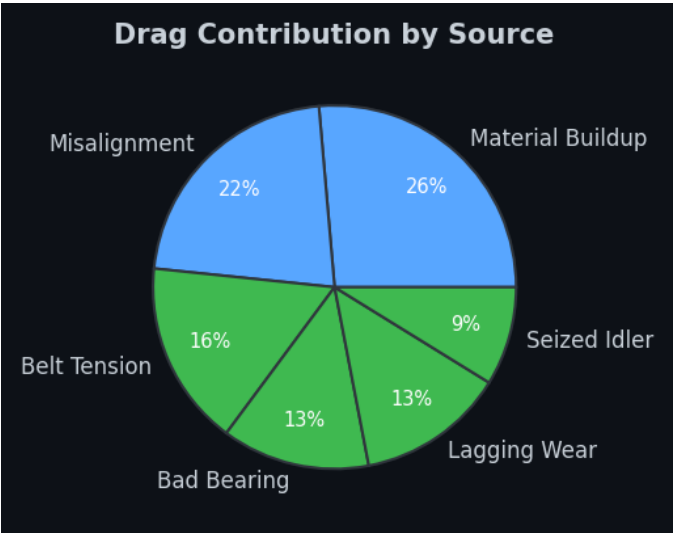
IDENTIFIED DRAG SOURCES

Source	Description	Match	Severity	Repair Cost
Material Buildup	Material carryback buildup on rollers/belt	25%	4/10	\$200
Misalignment	Belt or idler misalignment causing edge drag	25%	4/10	\$1,200
Belt Tension	Improper belt tension causing excess motor load	25%	3/10	\$600
Bad Bearing	Worn bearing generating excess heat and vibration	25%	3/10	\$400
Lagging Wear	Drive/snub pulley lagging worn — belt slipping	25%	3/10	\$1,500
Seized Idler	Seized or dragging idler roller — bearing failure	24%	2/10	\$800

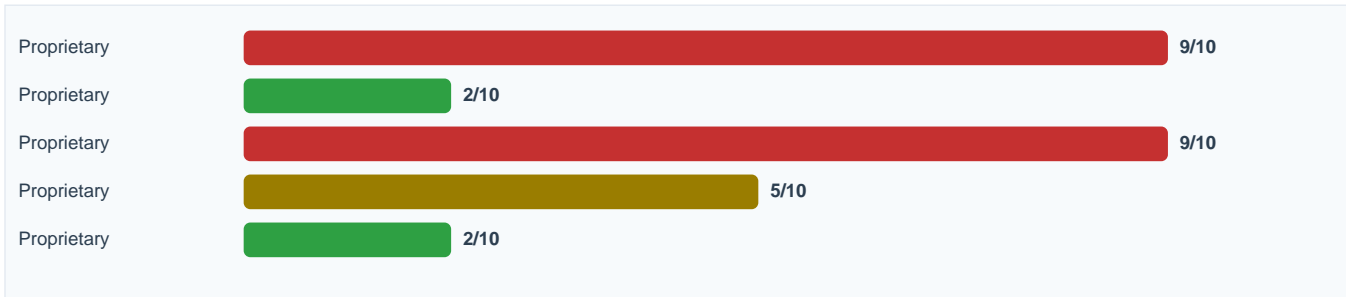
Consensus: 9/10 CRITICAL • Confidence: 40% • 30-Day Failure Risk: 38%
